# Manhole Inspection Summary

Manhole # S25G\_\_005MH

Insp Date: **8/31/07 10:14 AM**

**Location** Address: **1210 FAYETTE-FAIRMOUNT**

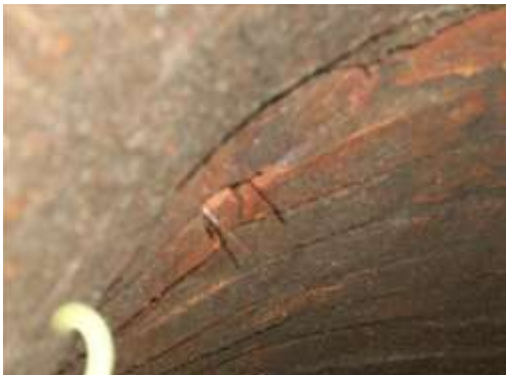
Defect 3

Condition: ☐ Sound ☐ Cracked ☒ **Root Intrusion** ☐ Loose Brick ☐ Deteriorated

ROOT INTRUSION OF THE CORBEL

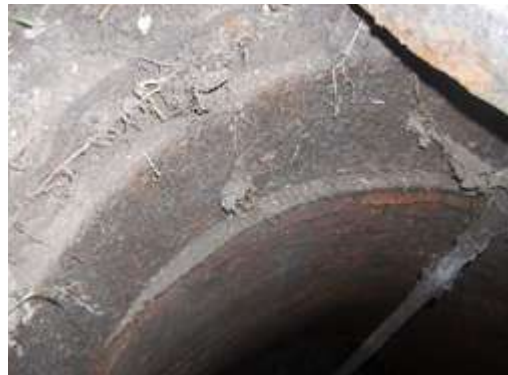
Defect 2

**Frame** Offset: **1** (in.) Condition: ☒ Sound ☐ Cracked ☐ Leaks

FRAME OFFSET

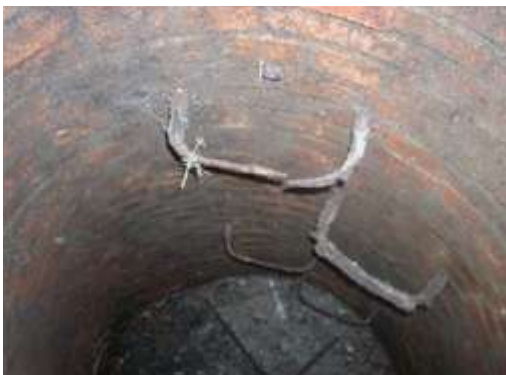
Defect 1

**Steps** Count: **4** Missing: **0** ☒ **Corroded**

CORRODED STEPS

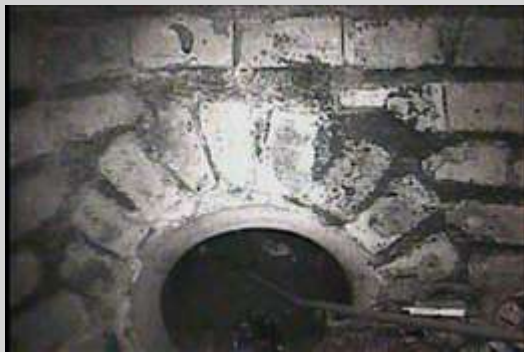
12 O'Clock Outflow

8 in. Circular Gravity Sewer  
Pipe Out @ 12 O'Clock

Infiltration: **None** Pipe Seal Cond: **Sound**
